ANDERSON HOME INSPECTOR
(206) 705-3478
andersonhomeinspectorahi@gmail.com

1234 Main Street
, WA

Buyer Name
10/17/2024 9:00AM

Inspector
Derryn Anderson
WA State Licensed Home Inspector
#24014631
(206) 705-3478
andersonhomeinspectorahi@gmail.com

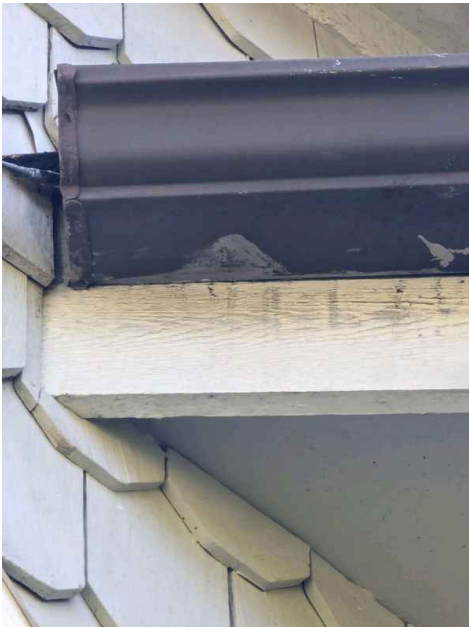
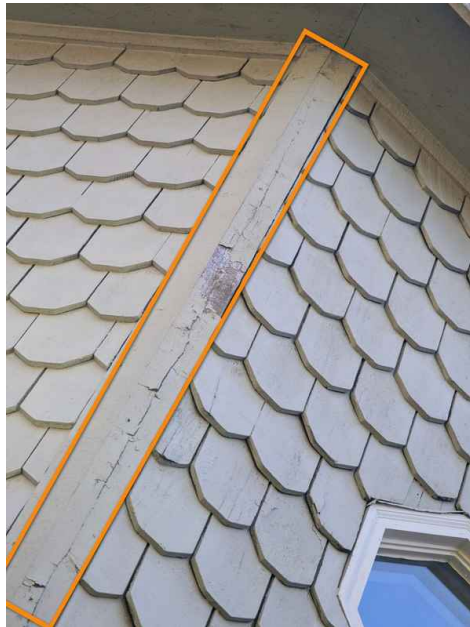
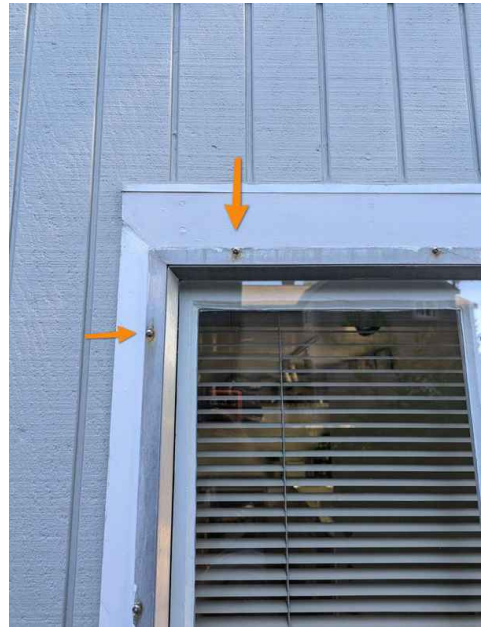
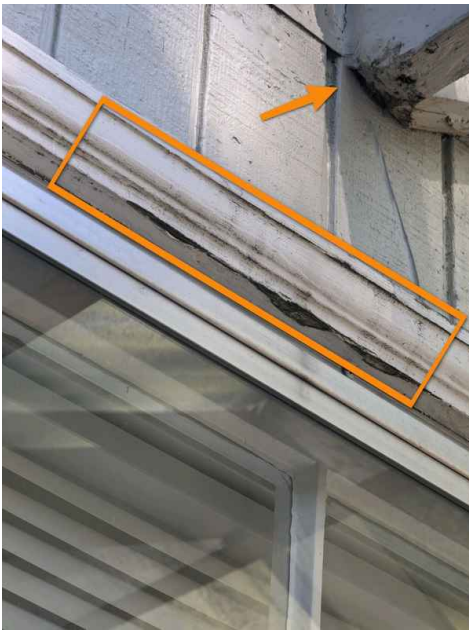
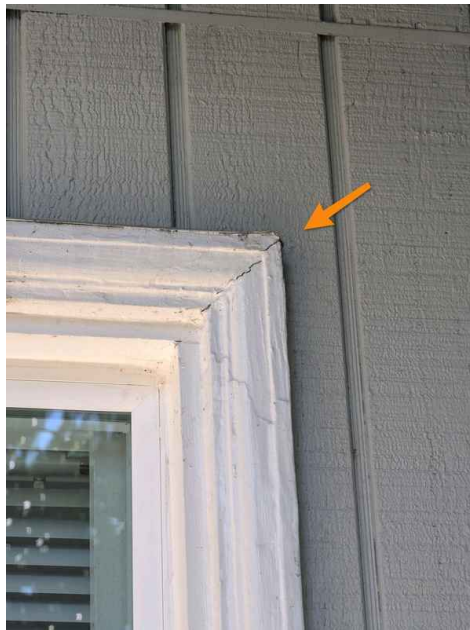
2.1.1 Observations

CAULKING, PATCHING, PAINTING, CARPENTRY REPAIR

Carpentry, caulking, painting and patching improvements recommend for the exterior of the home (around doors, windows, trims, and any other penetration).

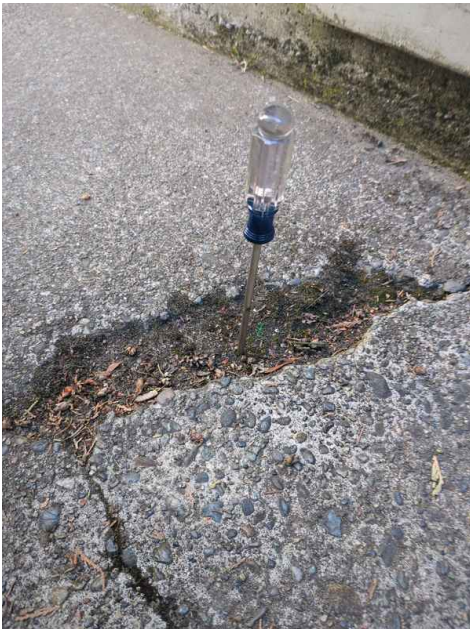
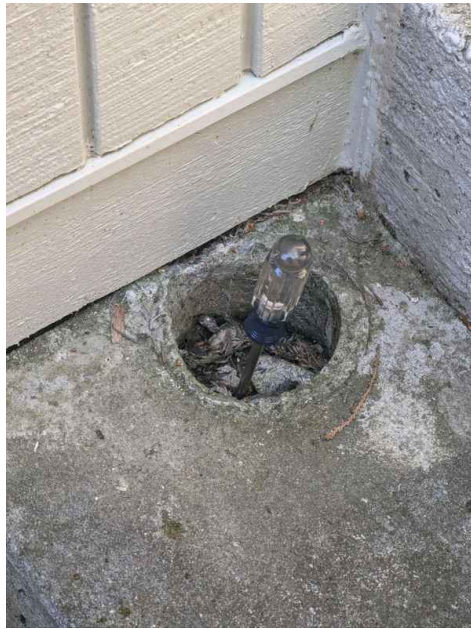
2.1.2 Observations

CONCRETE REPAIR

Holes and cracks at the rear walkway and landing. These areas should be covered/repared to prevent water penetration to soil under concrete. Recommend contacting a qualified professional to further evaluate/repair.

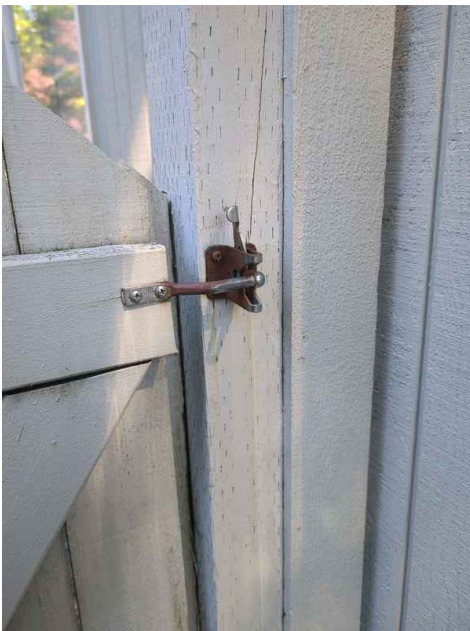
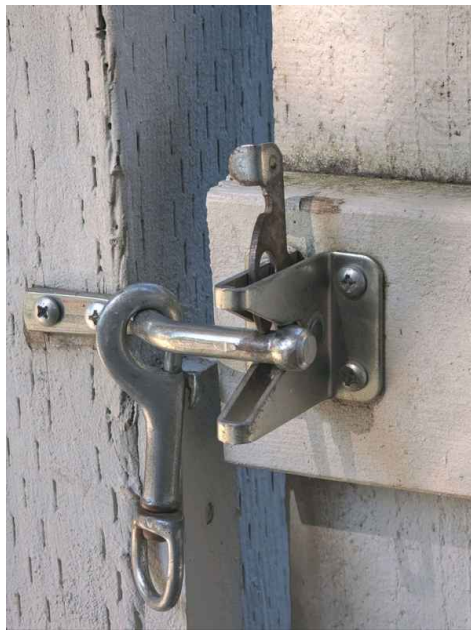
2.1.3 Observations

GATE LATCH REPAIR

Gate latches should operate easily and close without force. Gates at sides of the house and garage had to be pushed closed to fully latch. Contact a qualified professional to further evaluate/repair.

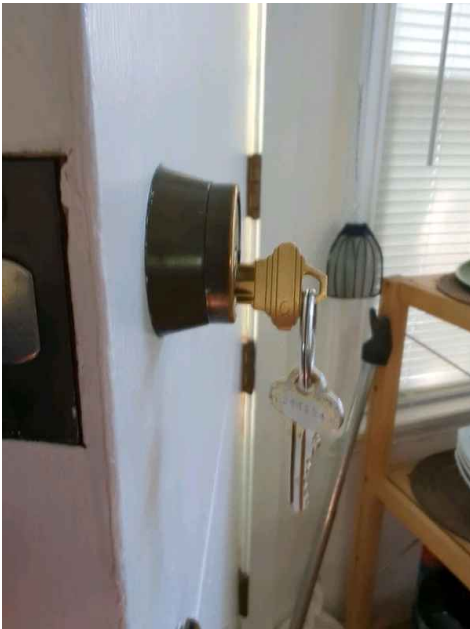
2.3.1 Doors

**REAR ENTRY DOOR
DOUBLE KEYED DEADBOLT CORRECTION**

A deadbolt with a thumb latch is needed. Contact a locksmith to further evaluate/repair.

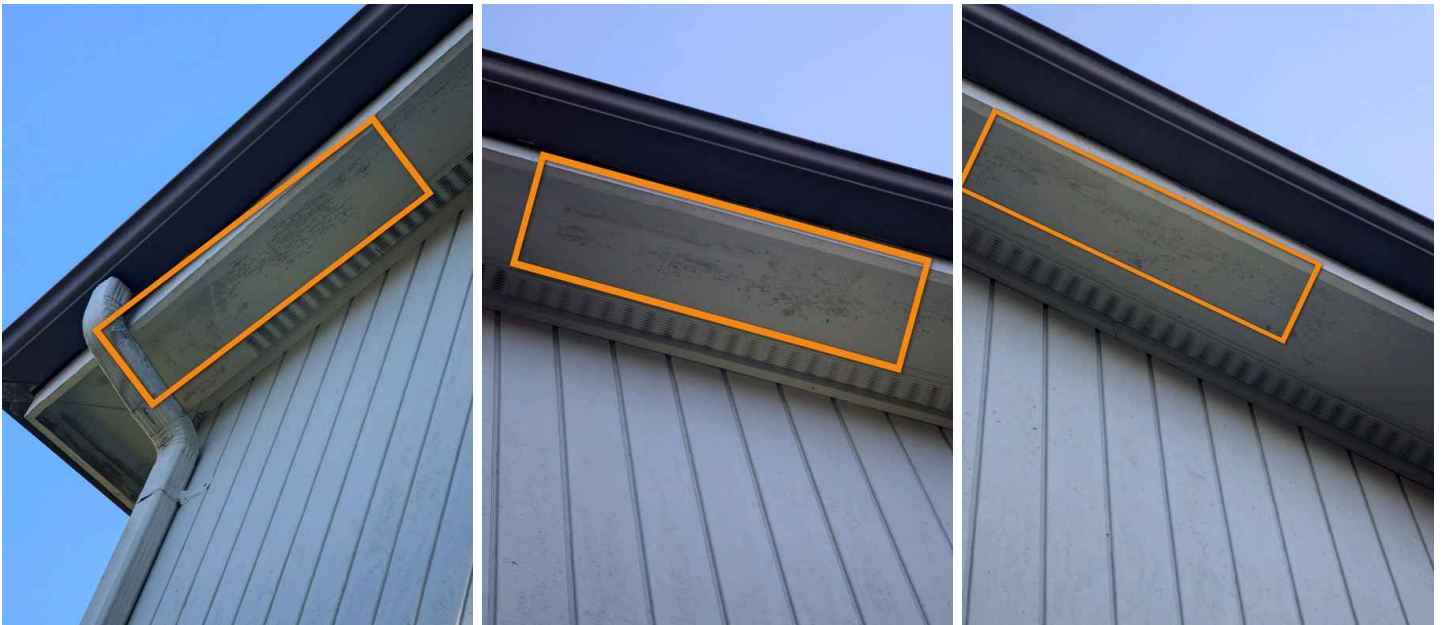
2.4.1 Siding, Flashing, Trim

EAVES HAD BIOLOGICAL GROWTH EVIDENCE

Eaves at the south of the roof had mildew-like staining present. Contact a qualified professional to further evaluate/repair.

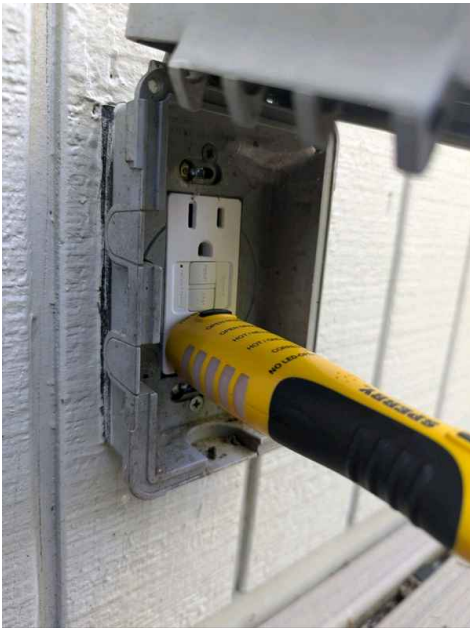
2.10.1 Exterior Electrical

GFCI PROTECTION NOT PRESENT

This outlet to the left of the front exterior door showed no power and could not be tested. Contact a licensed electrician to further evaluate/repair.

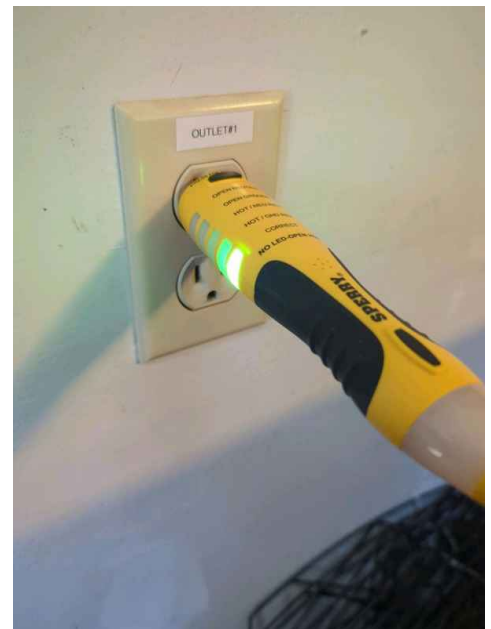
3.4.1 Electrical

GFCI PROTECTION NOT PRESENT

Contact a license electricians to further evaluate/repair.

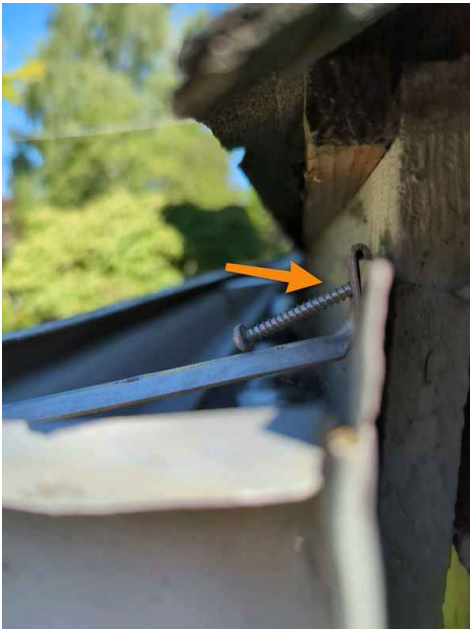
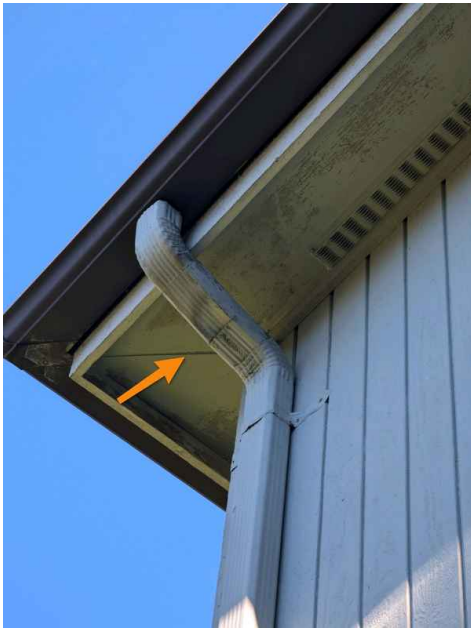
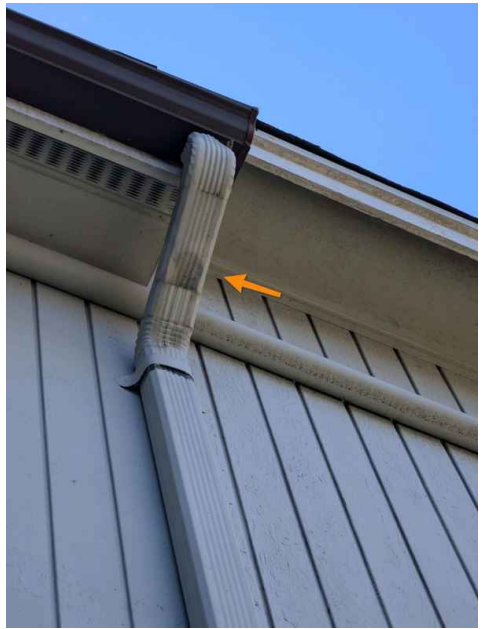
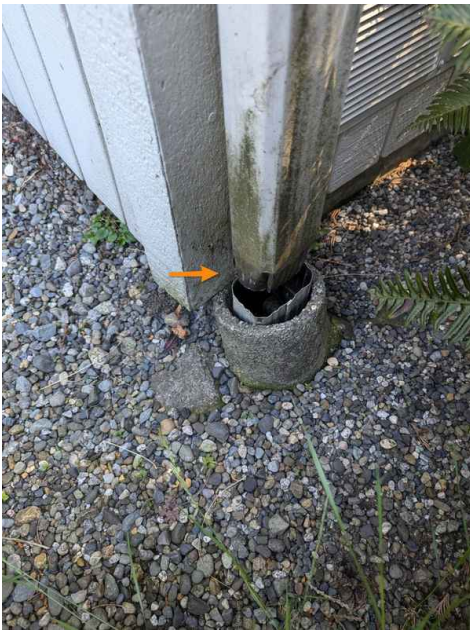
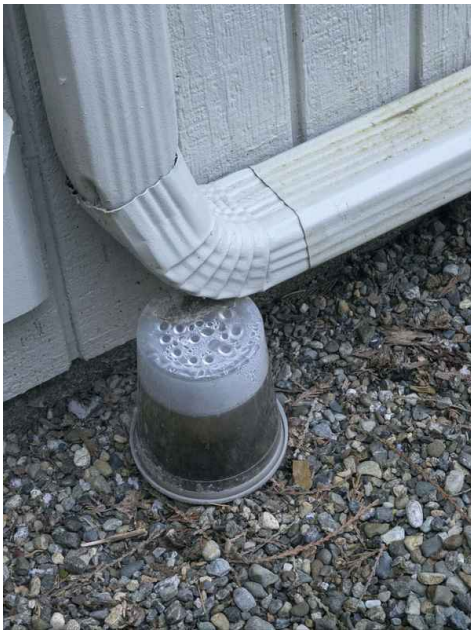
4.2.1 Roof Drainage

GUTTER/DRAIN SYSTEM REPAIR

Down spouts, gutters, and attachments showing signs of wear. Recommend the gutter system to be further evaluated/repaired by a qualified professional.

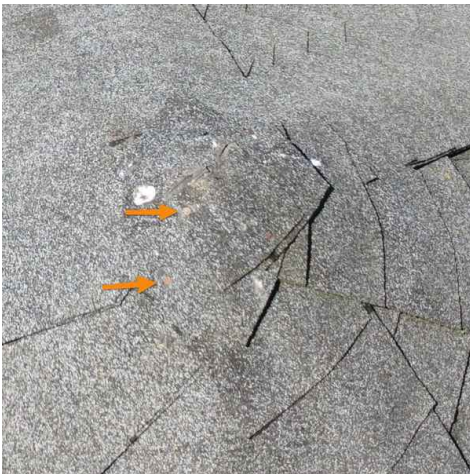
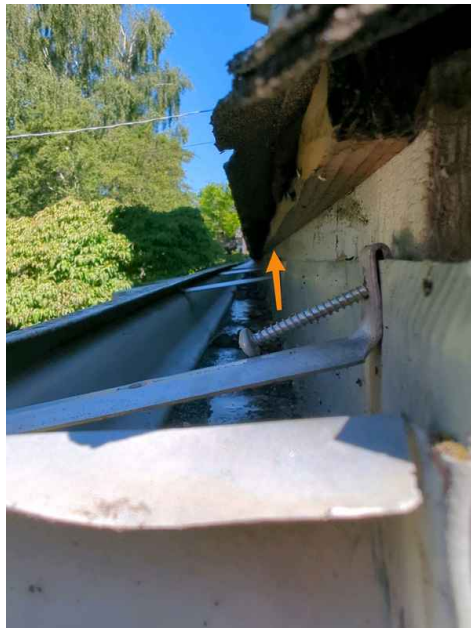
4.3.2 Roof Details

ROOF CORRECTIONS

Picture one shows exposed nail heads recommend being sealed. Picture two shows no drip edge flashing present, which prevents moisture wicking back into the roof sheathing at the edges. Contact a qualified professional to further evaluate/repair.

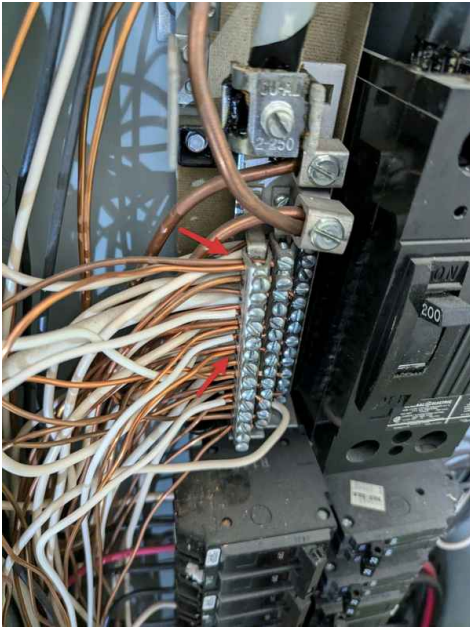
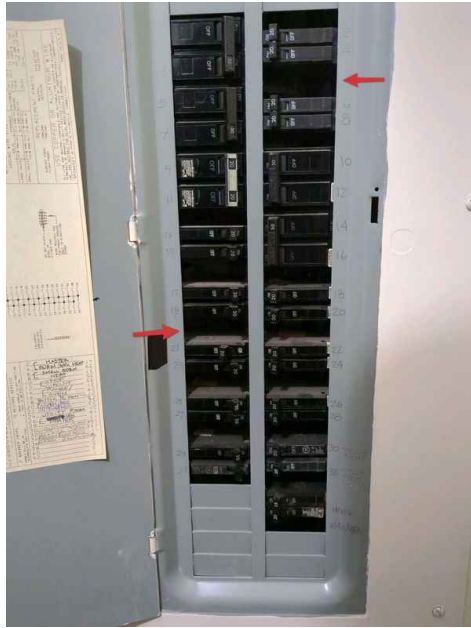
7.3.2 Main Panel

SERVICE BOX CORRECTIONS

Bus bar showing double tapped neutrals and could cause hazards. Spaces between fuses should be cover for added protection. Contact a license electrician to further evaluated/repair.

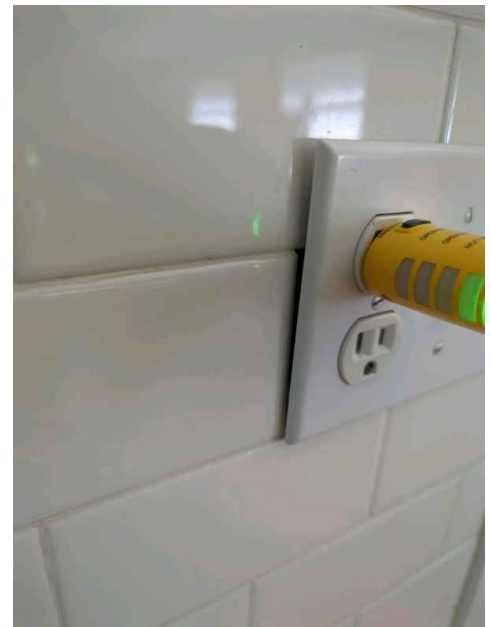
17.2.1 Electrical

OUTLET REPAIR

The outlet and face plate moved away from the wall during testing. Contact a licensed electrician to further evaluate/repair.

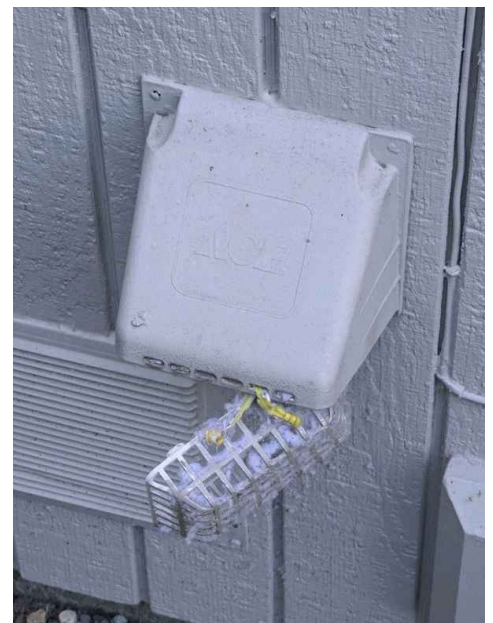
19.5.1 Appliances

DRYER VENT CORRECTION

Dryer vent in need of repair/cleaning. Contact a HVAC technician for further evaluate/repair.

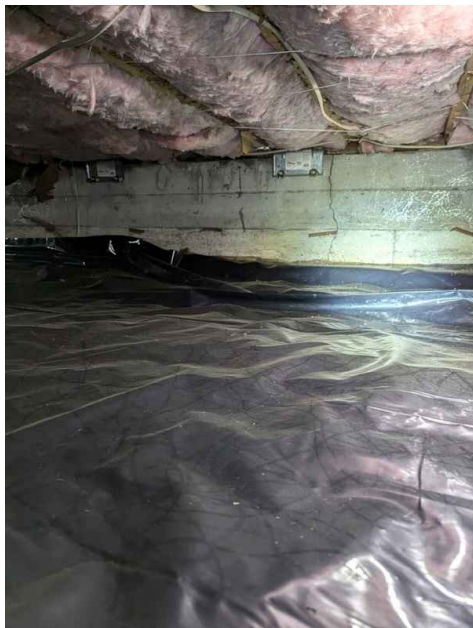
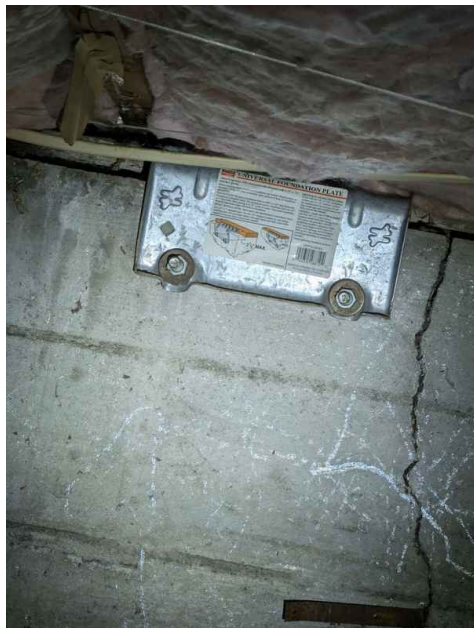
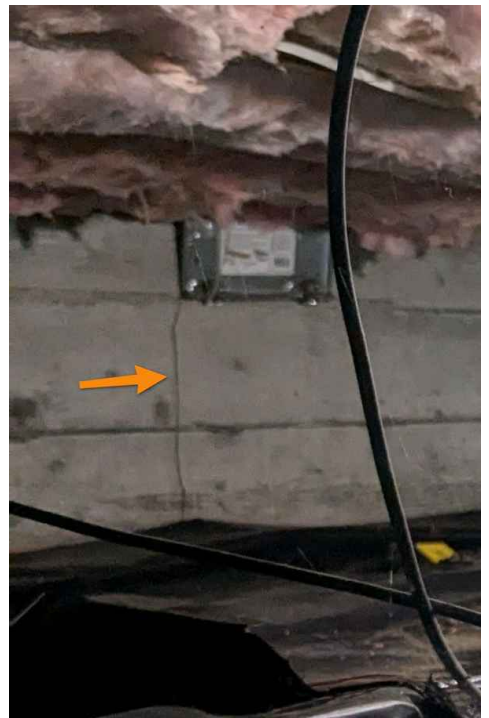
21.1.1 Observations

FOUNDATION CRACKS

Monitor the cracks every year for movement. Contact a licensed and bonded foundation contractor to further evaluate/repair.

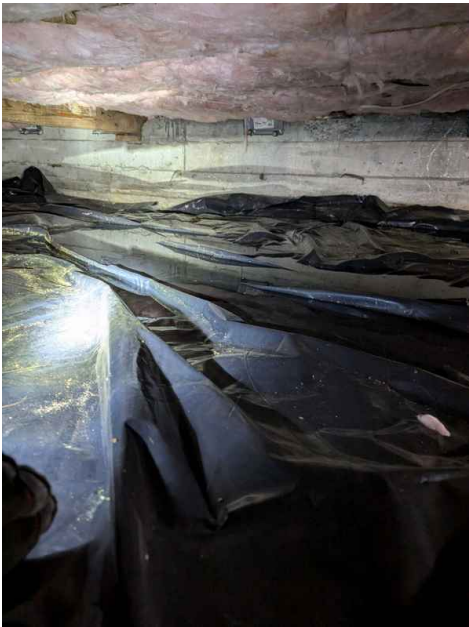
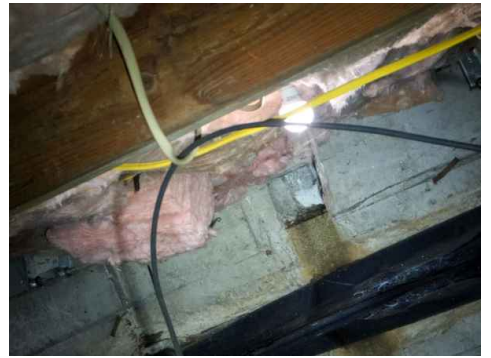
21.1.2 Observations

STANDING WATER

Standing water present at west and north west foundation walls. No active leak was detected. Contact a qualified professional to further evaluate/repair.

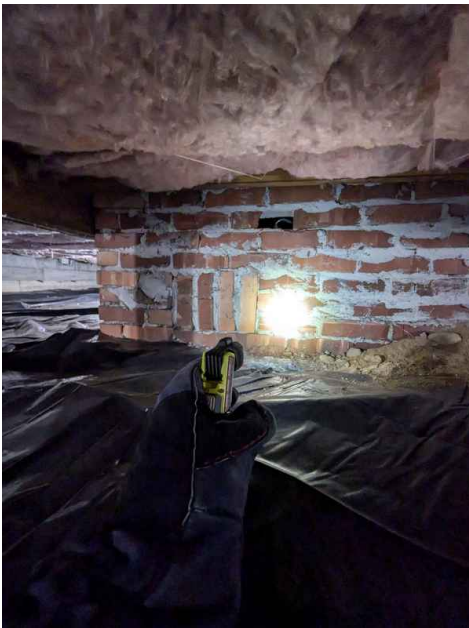
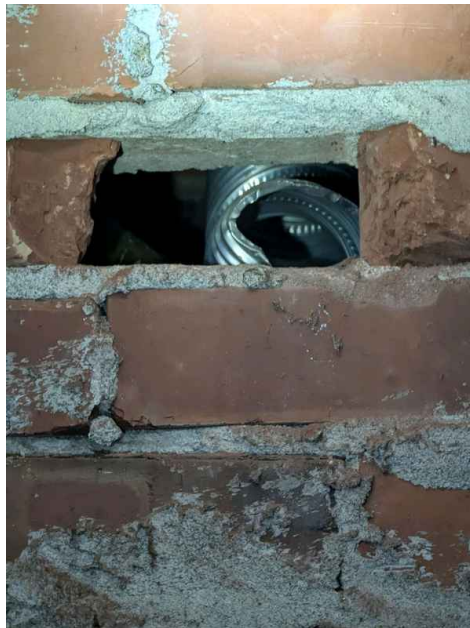
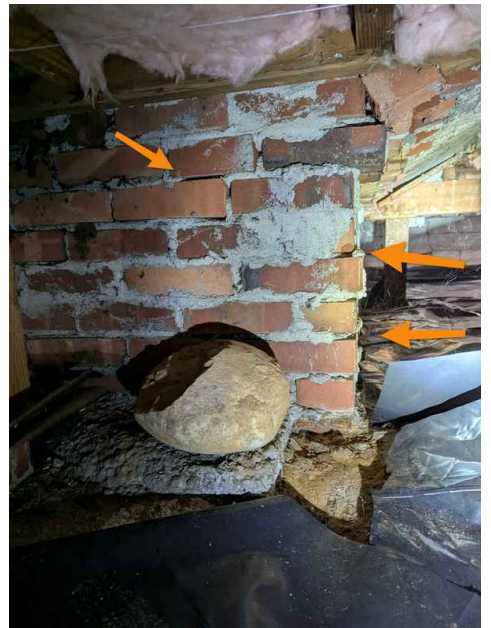
21.1.3 Observations

CRAWL SPACE BRICKWORK CORRECTIONS

Brickwork spalling and missing. Contact a qualified mason to further evaluate structural concerns or repair.

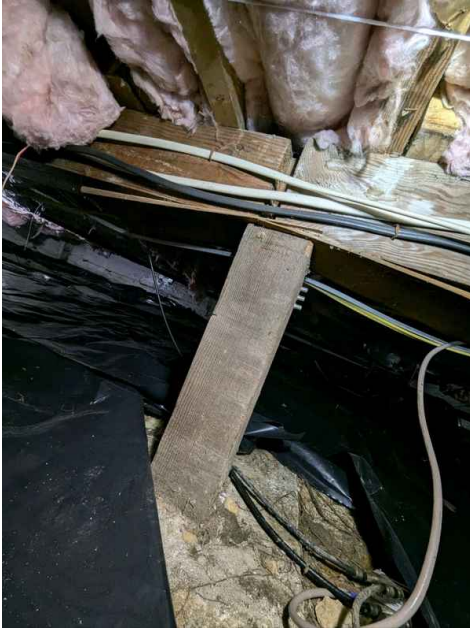
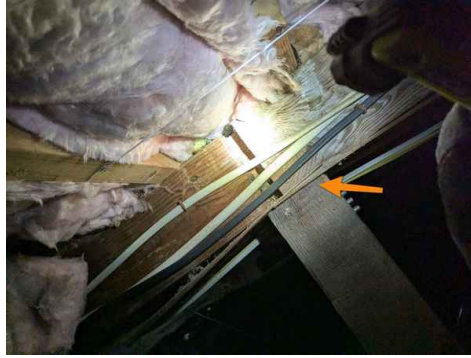
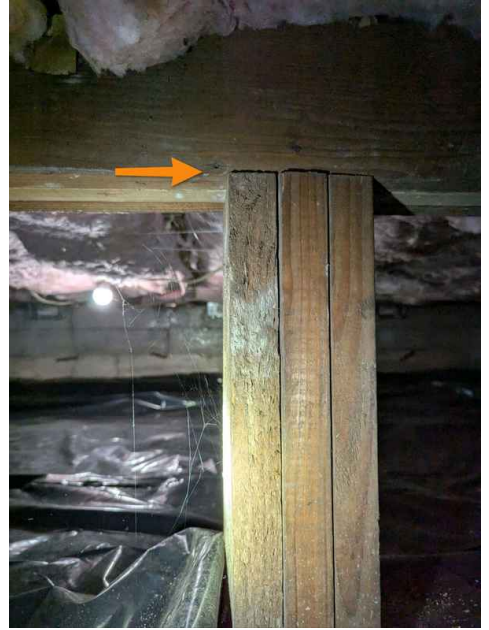
21.1.5 Observations

POST TO BEAM CONNECTORS CORRECTION

The framing would be sturdier if it had metal or wood connecting the post to the beam. Contact a qualified professional to further evaluate/repair.
