ANDERSON HOME INSPECTOR
(206) 705-3478
andersonhomeinspectorahi@gmail.com

1234 Main Street
, WA

Buyer Name
10/17/2024 9:00AM

Inspector
Derryn Anderson
WA State Licensed Home Inspector
#24014631
(206) 705-3478
andersonhomeinspectorahi@gmail.com

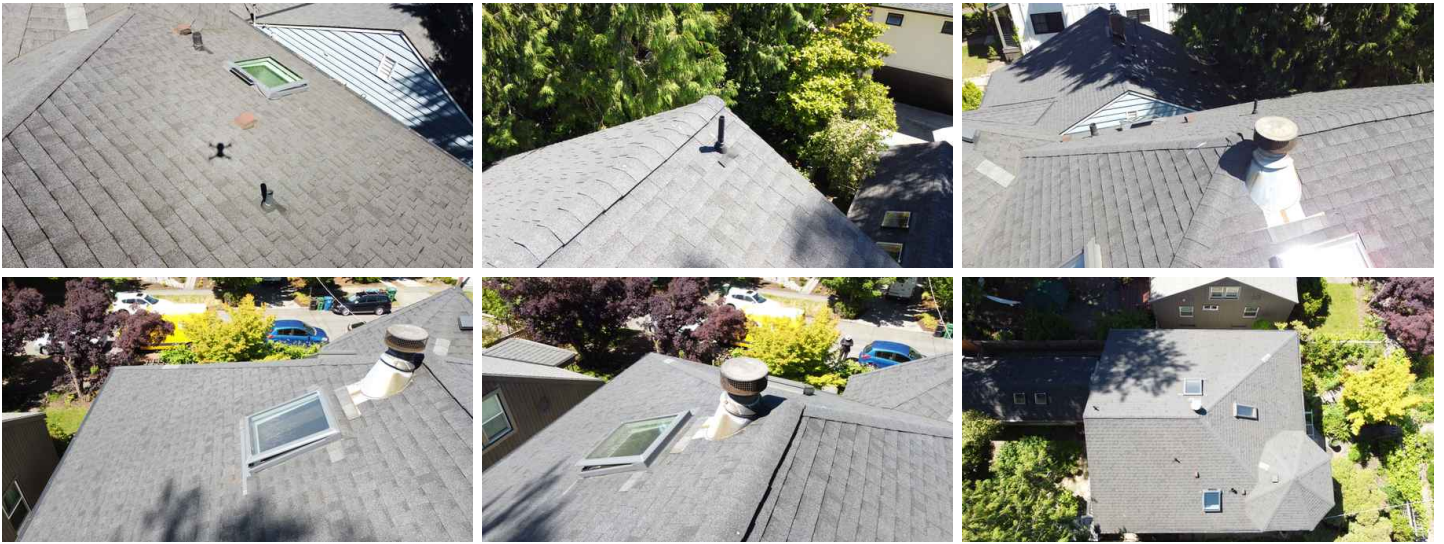
4.3.2 Roof Details

Picture one shows exposed nail heads recommend being sealed. Picture two shows no drip edge flashing present, which prevents moisture wicking back into the roof sheathing at the edges. Contact a qualified professional to further evaluate/repair.

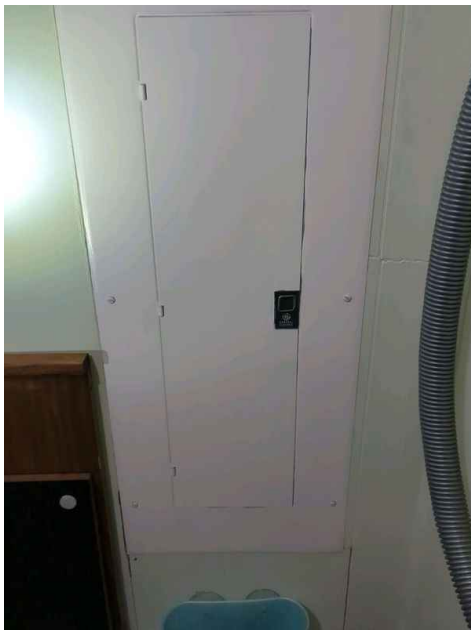
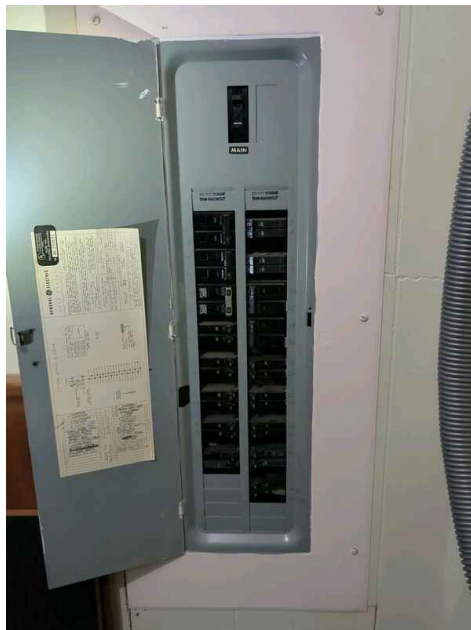
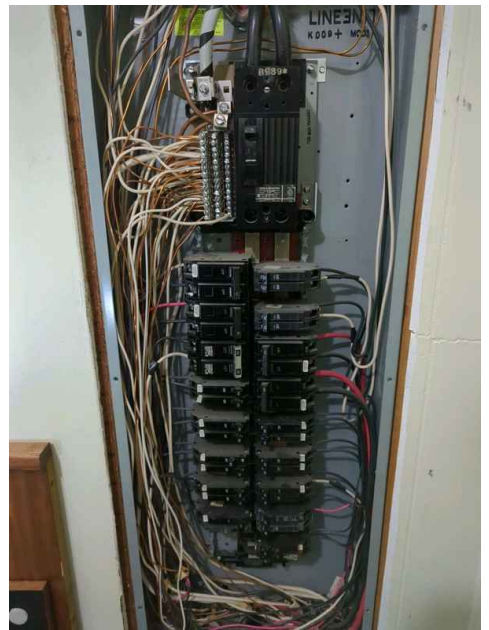
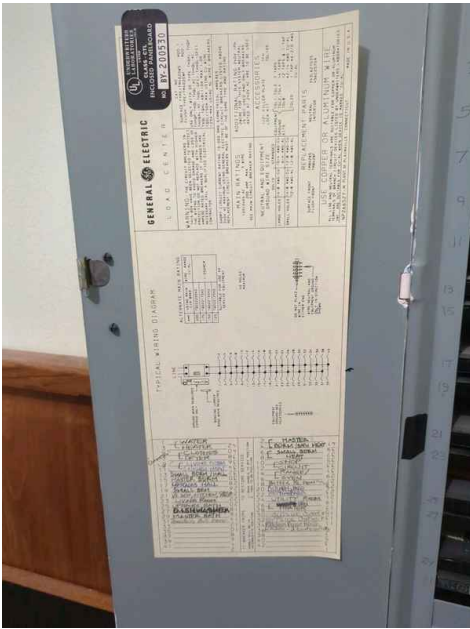
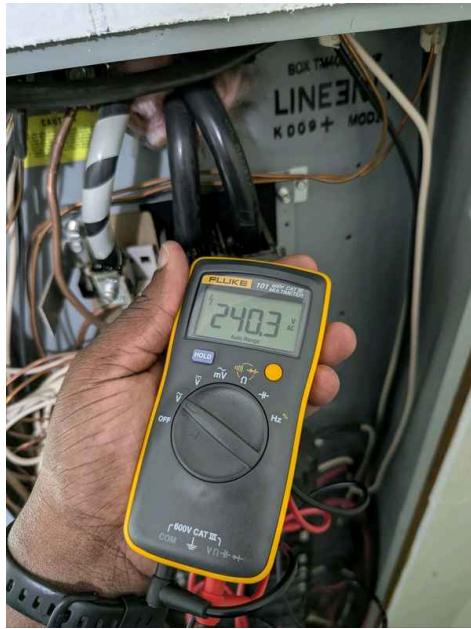
7.3.2 Main Panel

SERVICE BOX CORRECTIONS

Bus bar showing double tapped neutrals and could cause hazards. Spaces between fuses should be cover for added protection. Contact a license electrician to further evaluated/repair.

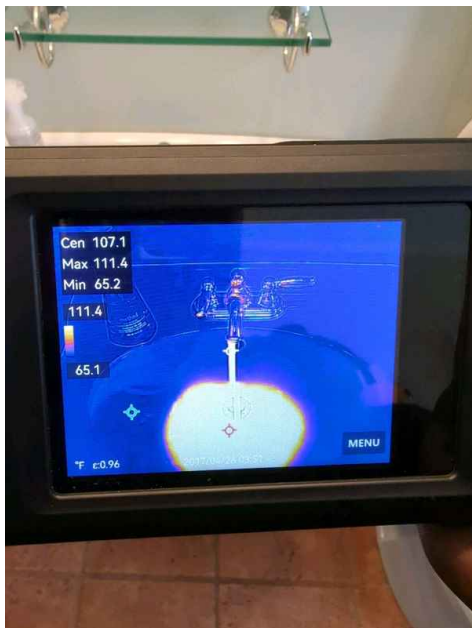
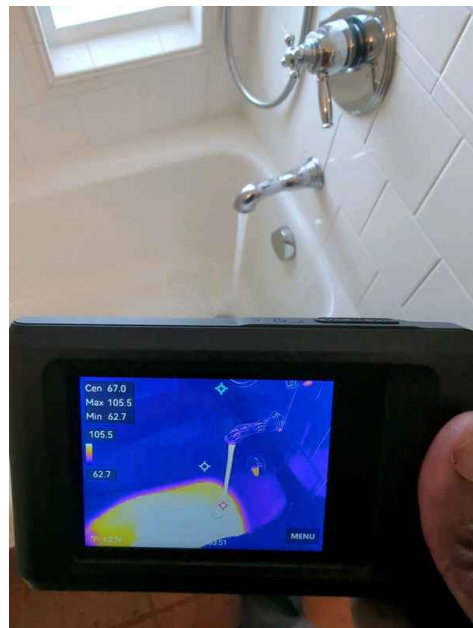
Below 120 degrees.

The generally accepted safe water temperature is 120 degrees.

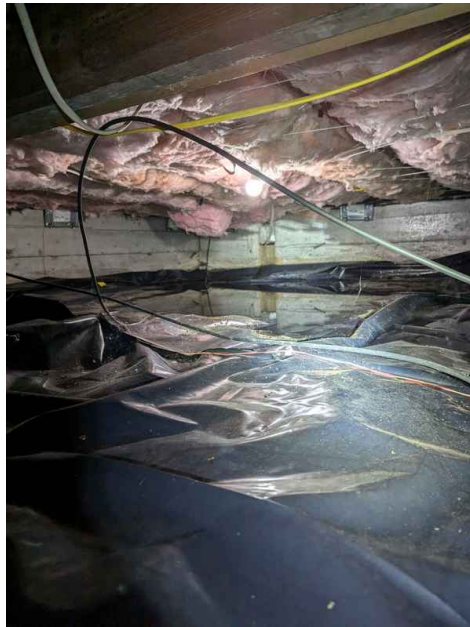
Water

Standing water present at west and north west foundation walls. No active leak was detected. Contact a qualified professional to further evaluate/repair.

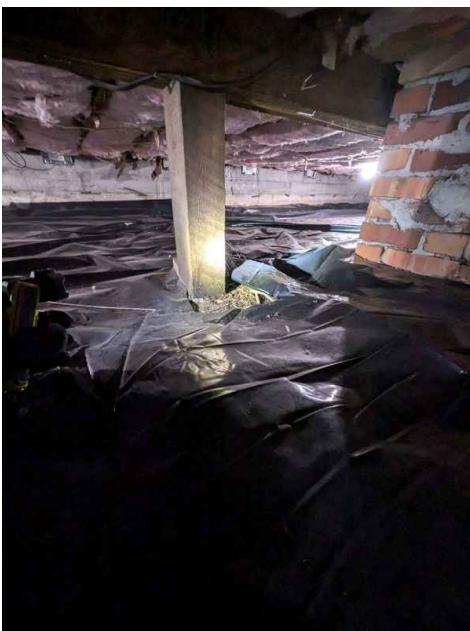
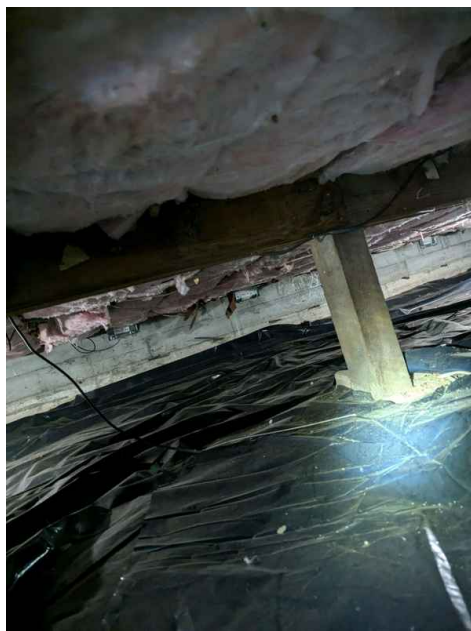
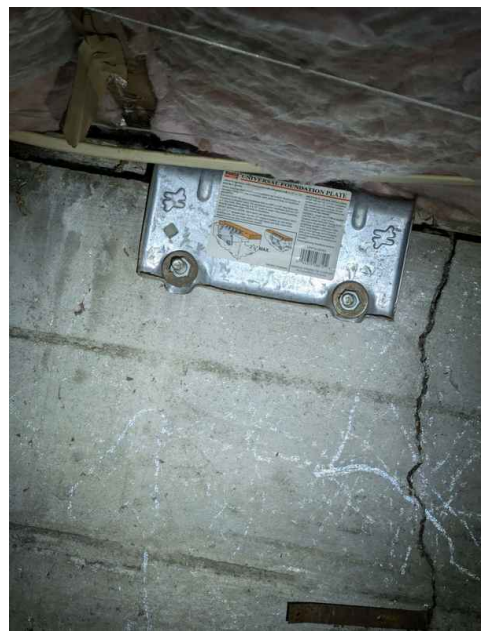
Crack

FOUNDATION CRACKS

Monitor the cracks every year for movement. Contact a licensed and bonded foundation contractor to further evaluate/repair.
